**RECONNAISSANCE
HYDROLOGIC & ENGINEERING INVESTIGATIONS**

ENGLEWOOD DAM

Arapahoe County, Colorado

Job No. 16849-7715

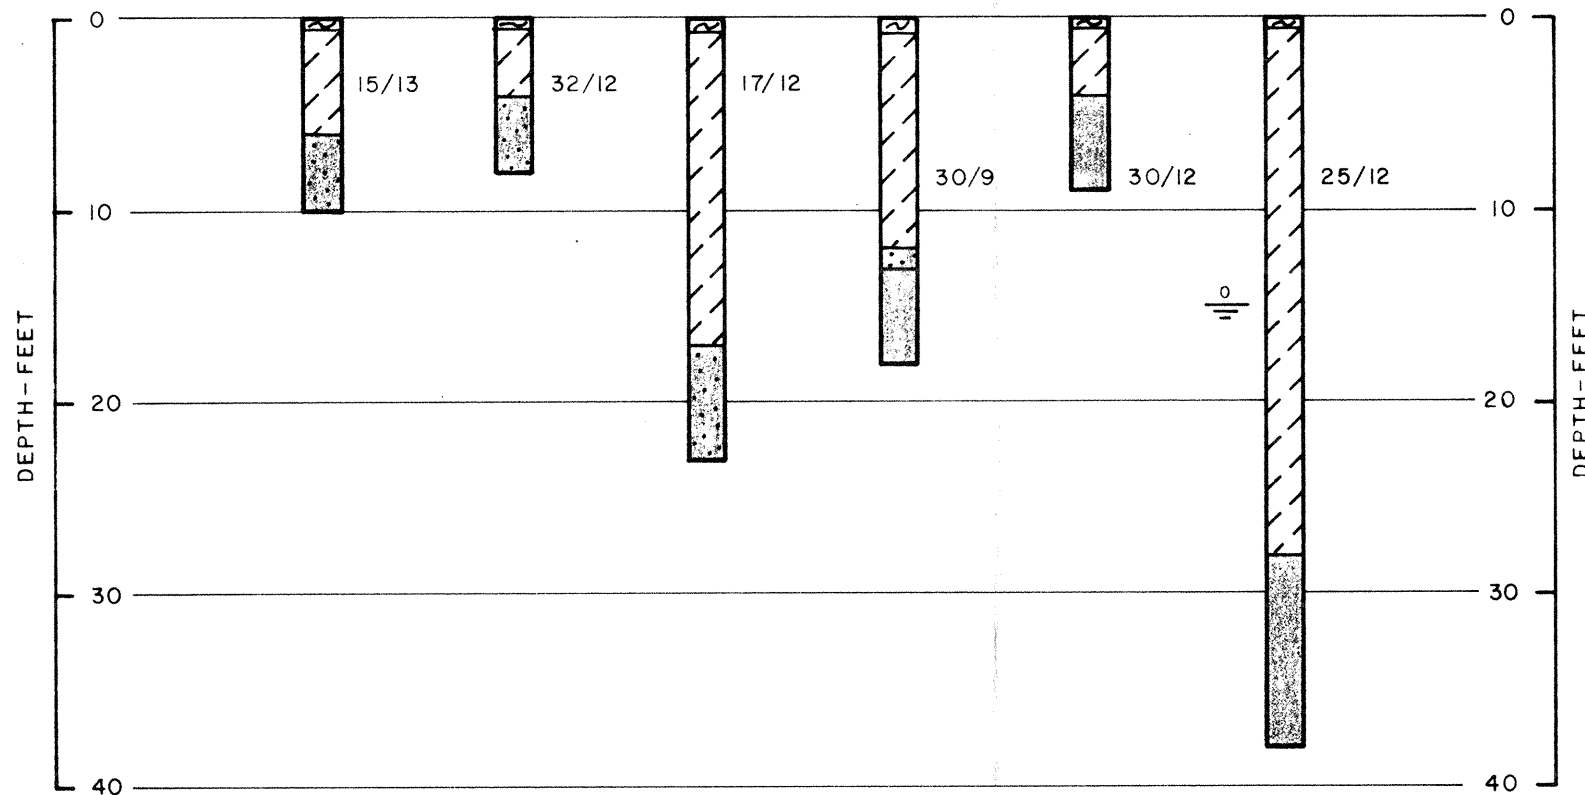
FIG. 7

Our test holes in the reservoir area upstream of the dam revealed that borrow soils from within the reservoir area would be predominately clays, as show on Figure 7. Bedrock was found at depths of about 5 feet in three of the six test holes drilled and in general should be at relatively shallow depth. In our opinion, any of the bedrock soils which would break down during excavation and/or in placement could also be used as a source of borrow material for proposed raises of the dam. However, we do not believe it would be necessary to excavate into bedrock and it seems probable that more detailed investigations would verify an adequate amount of overburden clays of adequate depth for borrow materials.

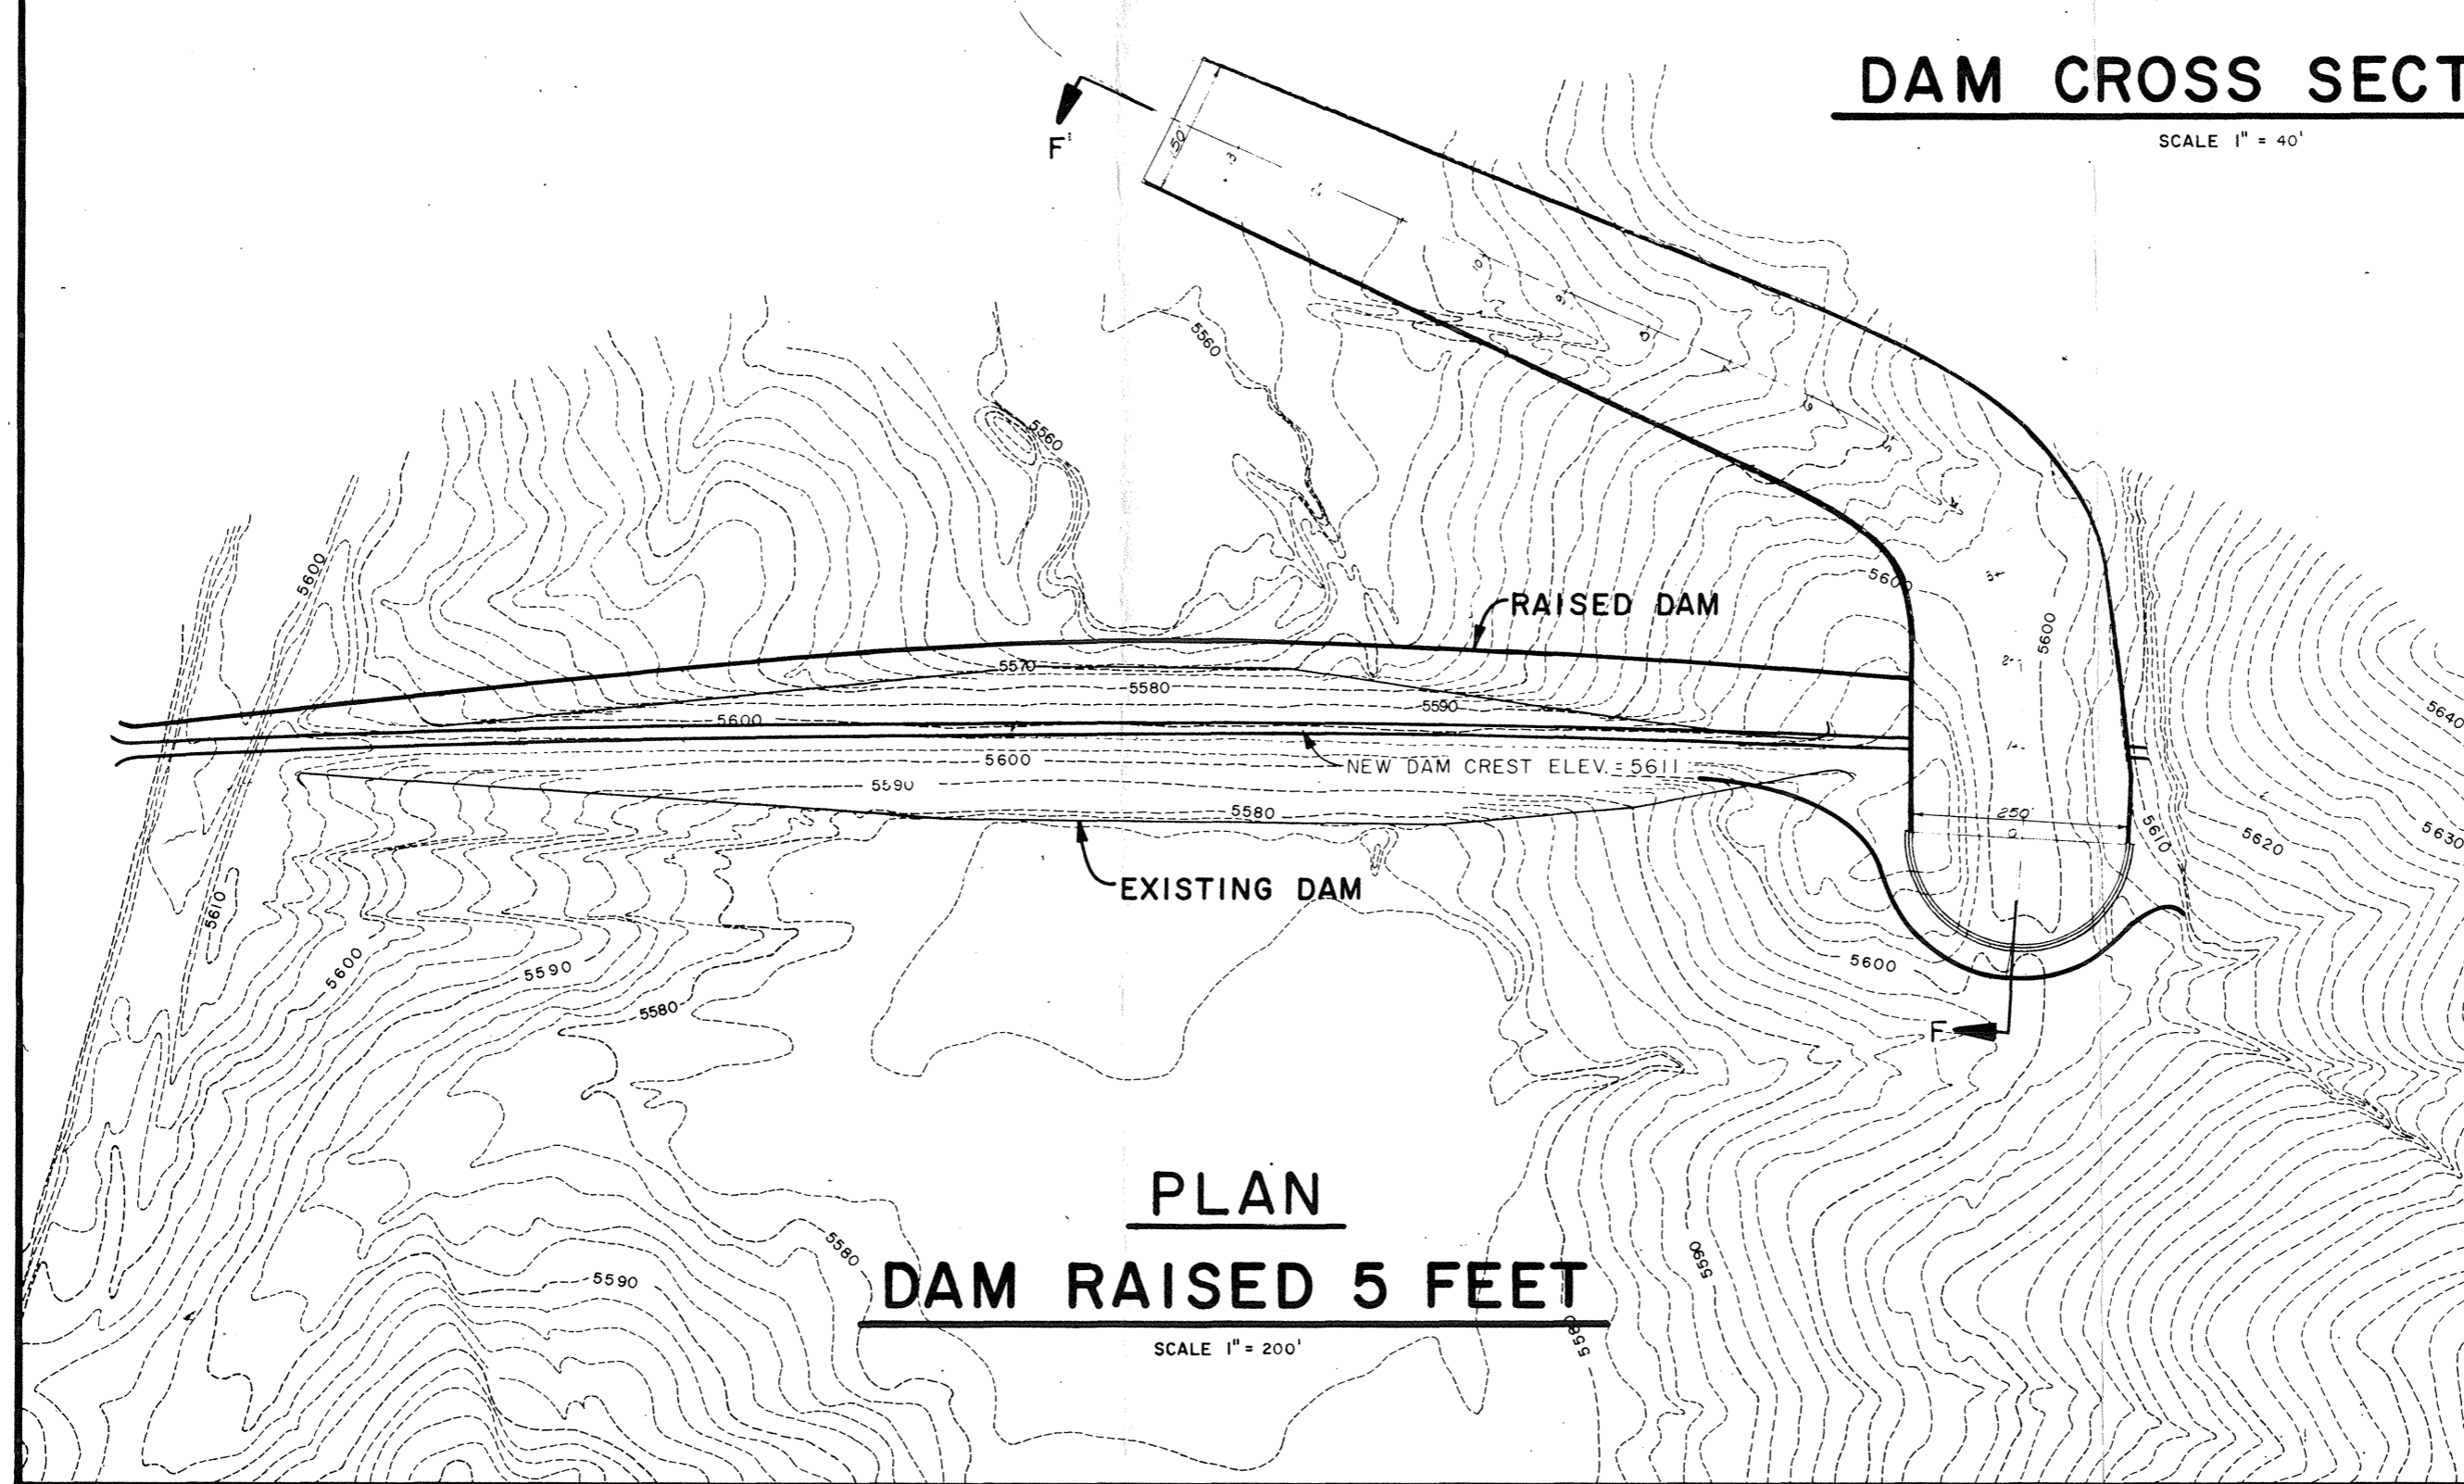
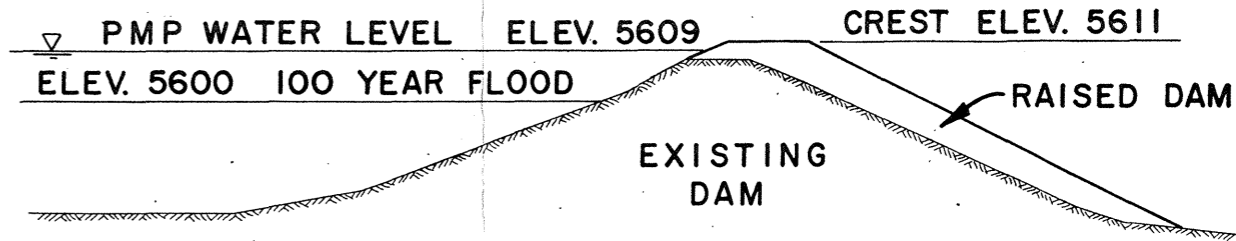
RIGHT ABUTMENT SPILLWAY
 DAM RAISED
 5 FEET
 ENGLEWOOD DAM

NEW CONCRETE LINED SPILLWAY
 FOR Q = 41,000 C.F.S.
 DAM ELEV. = 5611 H.W.L. ELEV. = 5609
 SPILLWAY LENGTH = 460' ELEV. = 5600

proposed dam raises and spillway locations are shown on Figures 8, 9, and 10. Preliminary summaries of cost estimates for these various plans are shown on Table III. In our opinion, all of the schemes shown are feasible from the soils engineering, hydrologic and geologic standpoint; however, the scheme involving a 10-foot raise of the dam and a spillway over the left abutment as shown on Figure 10, appears to be the most economical of the three studied.

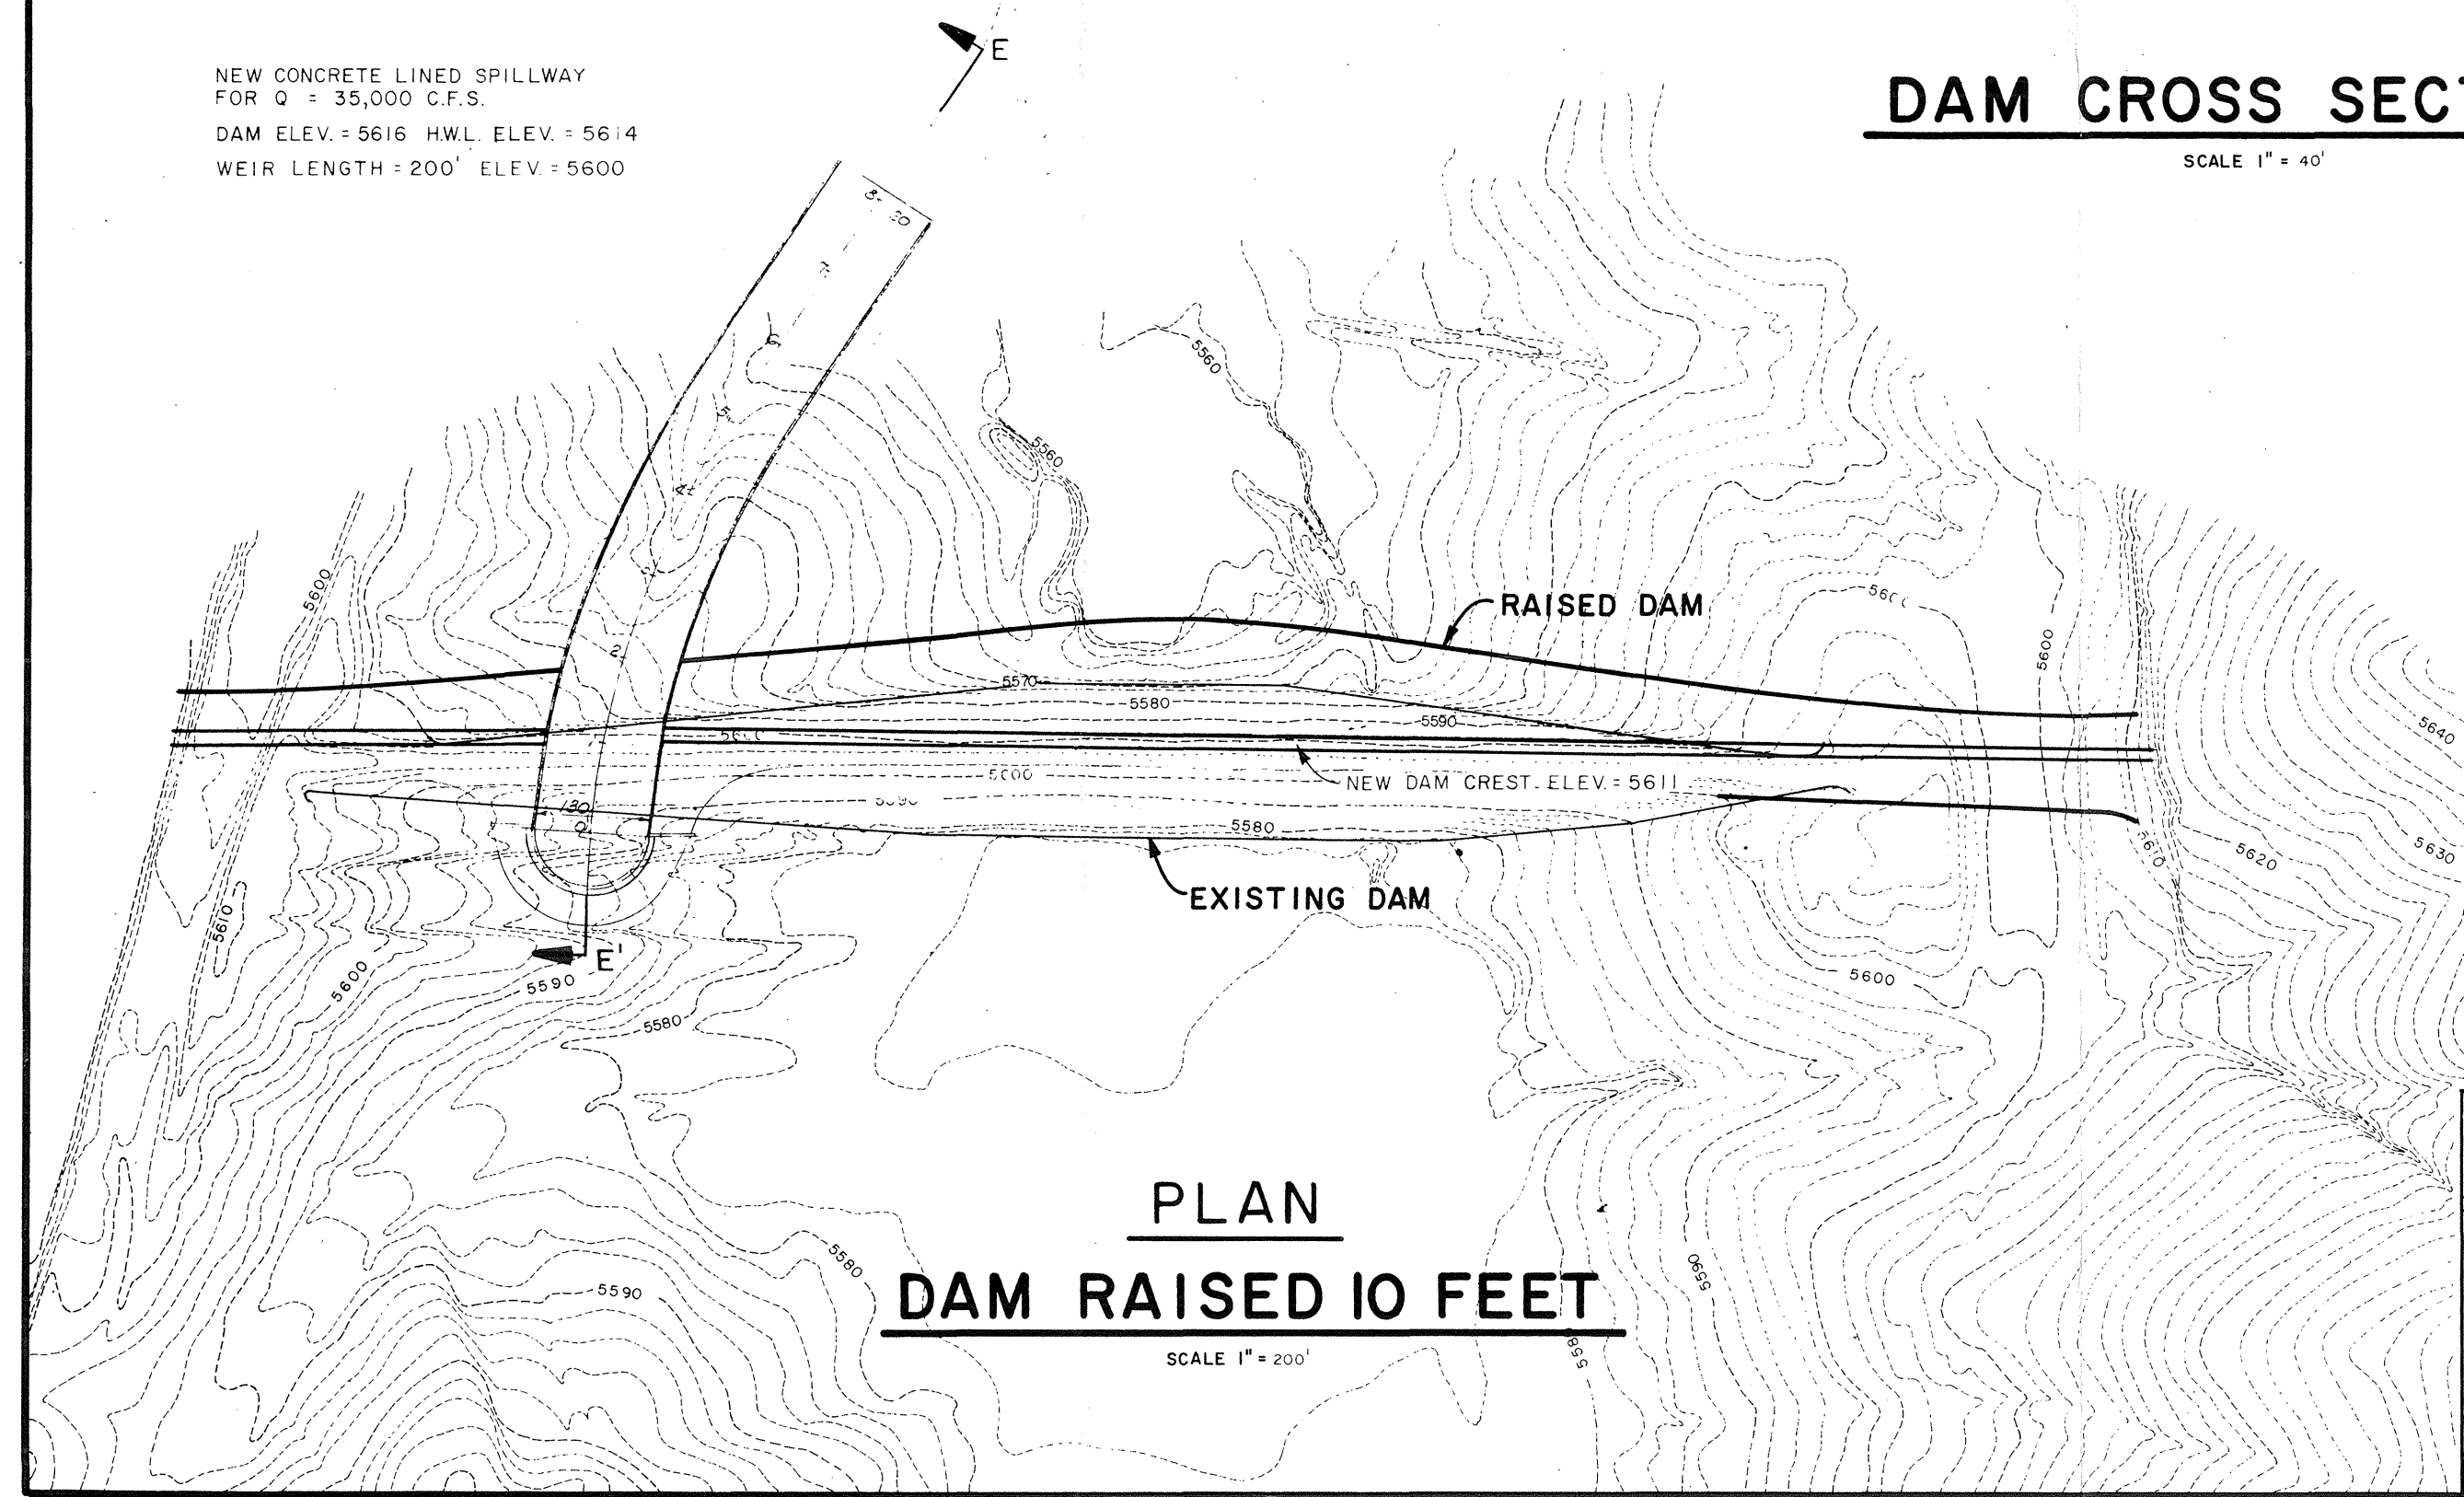
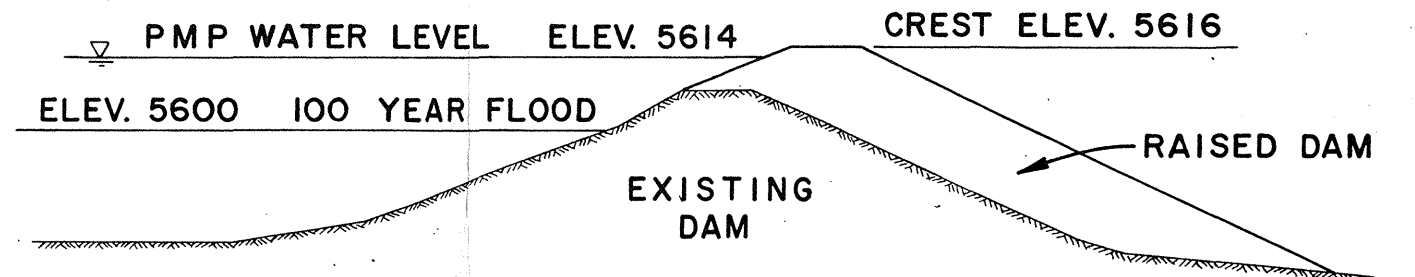
LEFT ABUTMENT SPILLWAY
 DAM RAISED
 10 FEET
 ENGLEWOOD DAM

NEW CONCRETE LINED SPILLWAY
 FOR Q = 35,000 C.F.S.
 DAM ELEV. = 5616 H.W.L. ELEV. = 5614
 WEIR LENGTH = 200' ELEV. = 5600

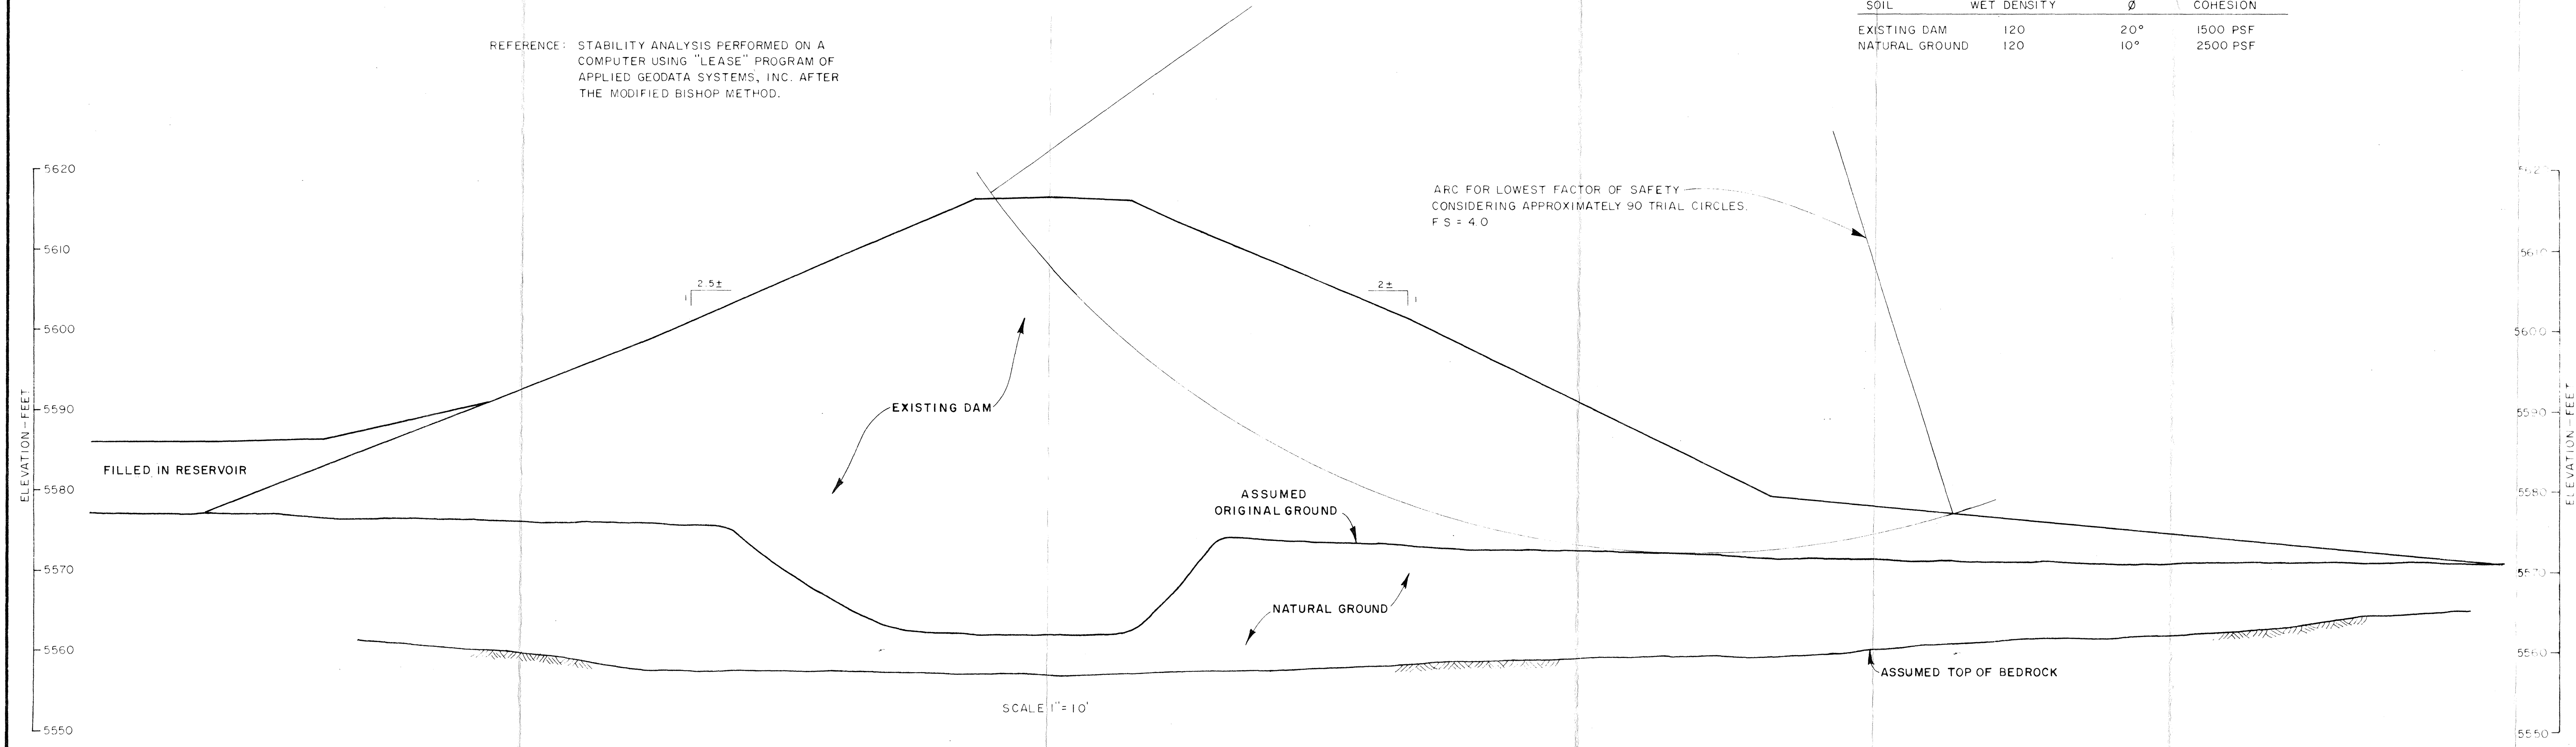
FIG. 11

Our investigations included theoretical stability analyses of the downstream slope performed on an embankment section constructed from cross section surveys by Merrick and Company. The results of this stability analyses are shown on Figure 11. This analysis was made to provide information to assist in judgment

decisions on proposed raising of the existing dam and use of the present dam. The assumptions made, although based upon data which is not of the highest order of accuracy, indicate the dam to be stable.

SOIL	WET DENSITY	ϕ	COHESION
EXISTING DAM	120	20°	1500 PSF
NATURAL GROUND	120	10°	2500 PSF

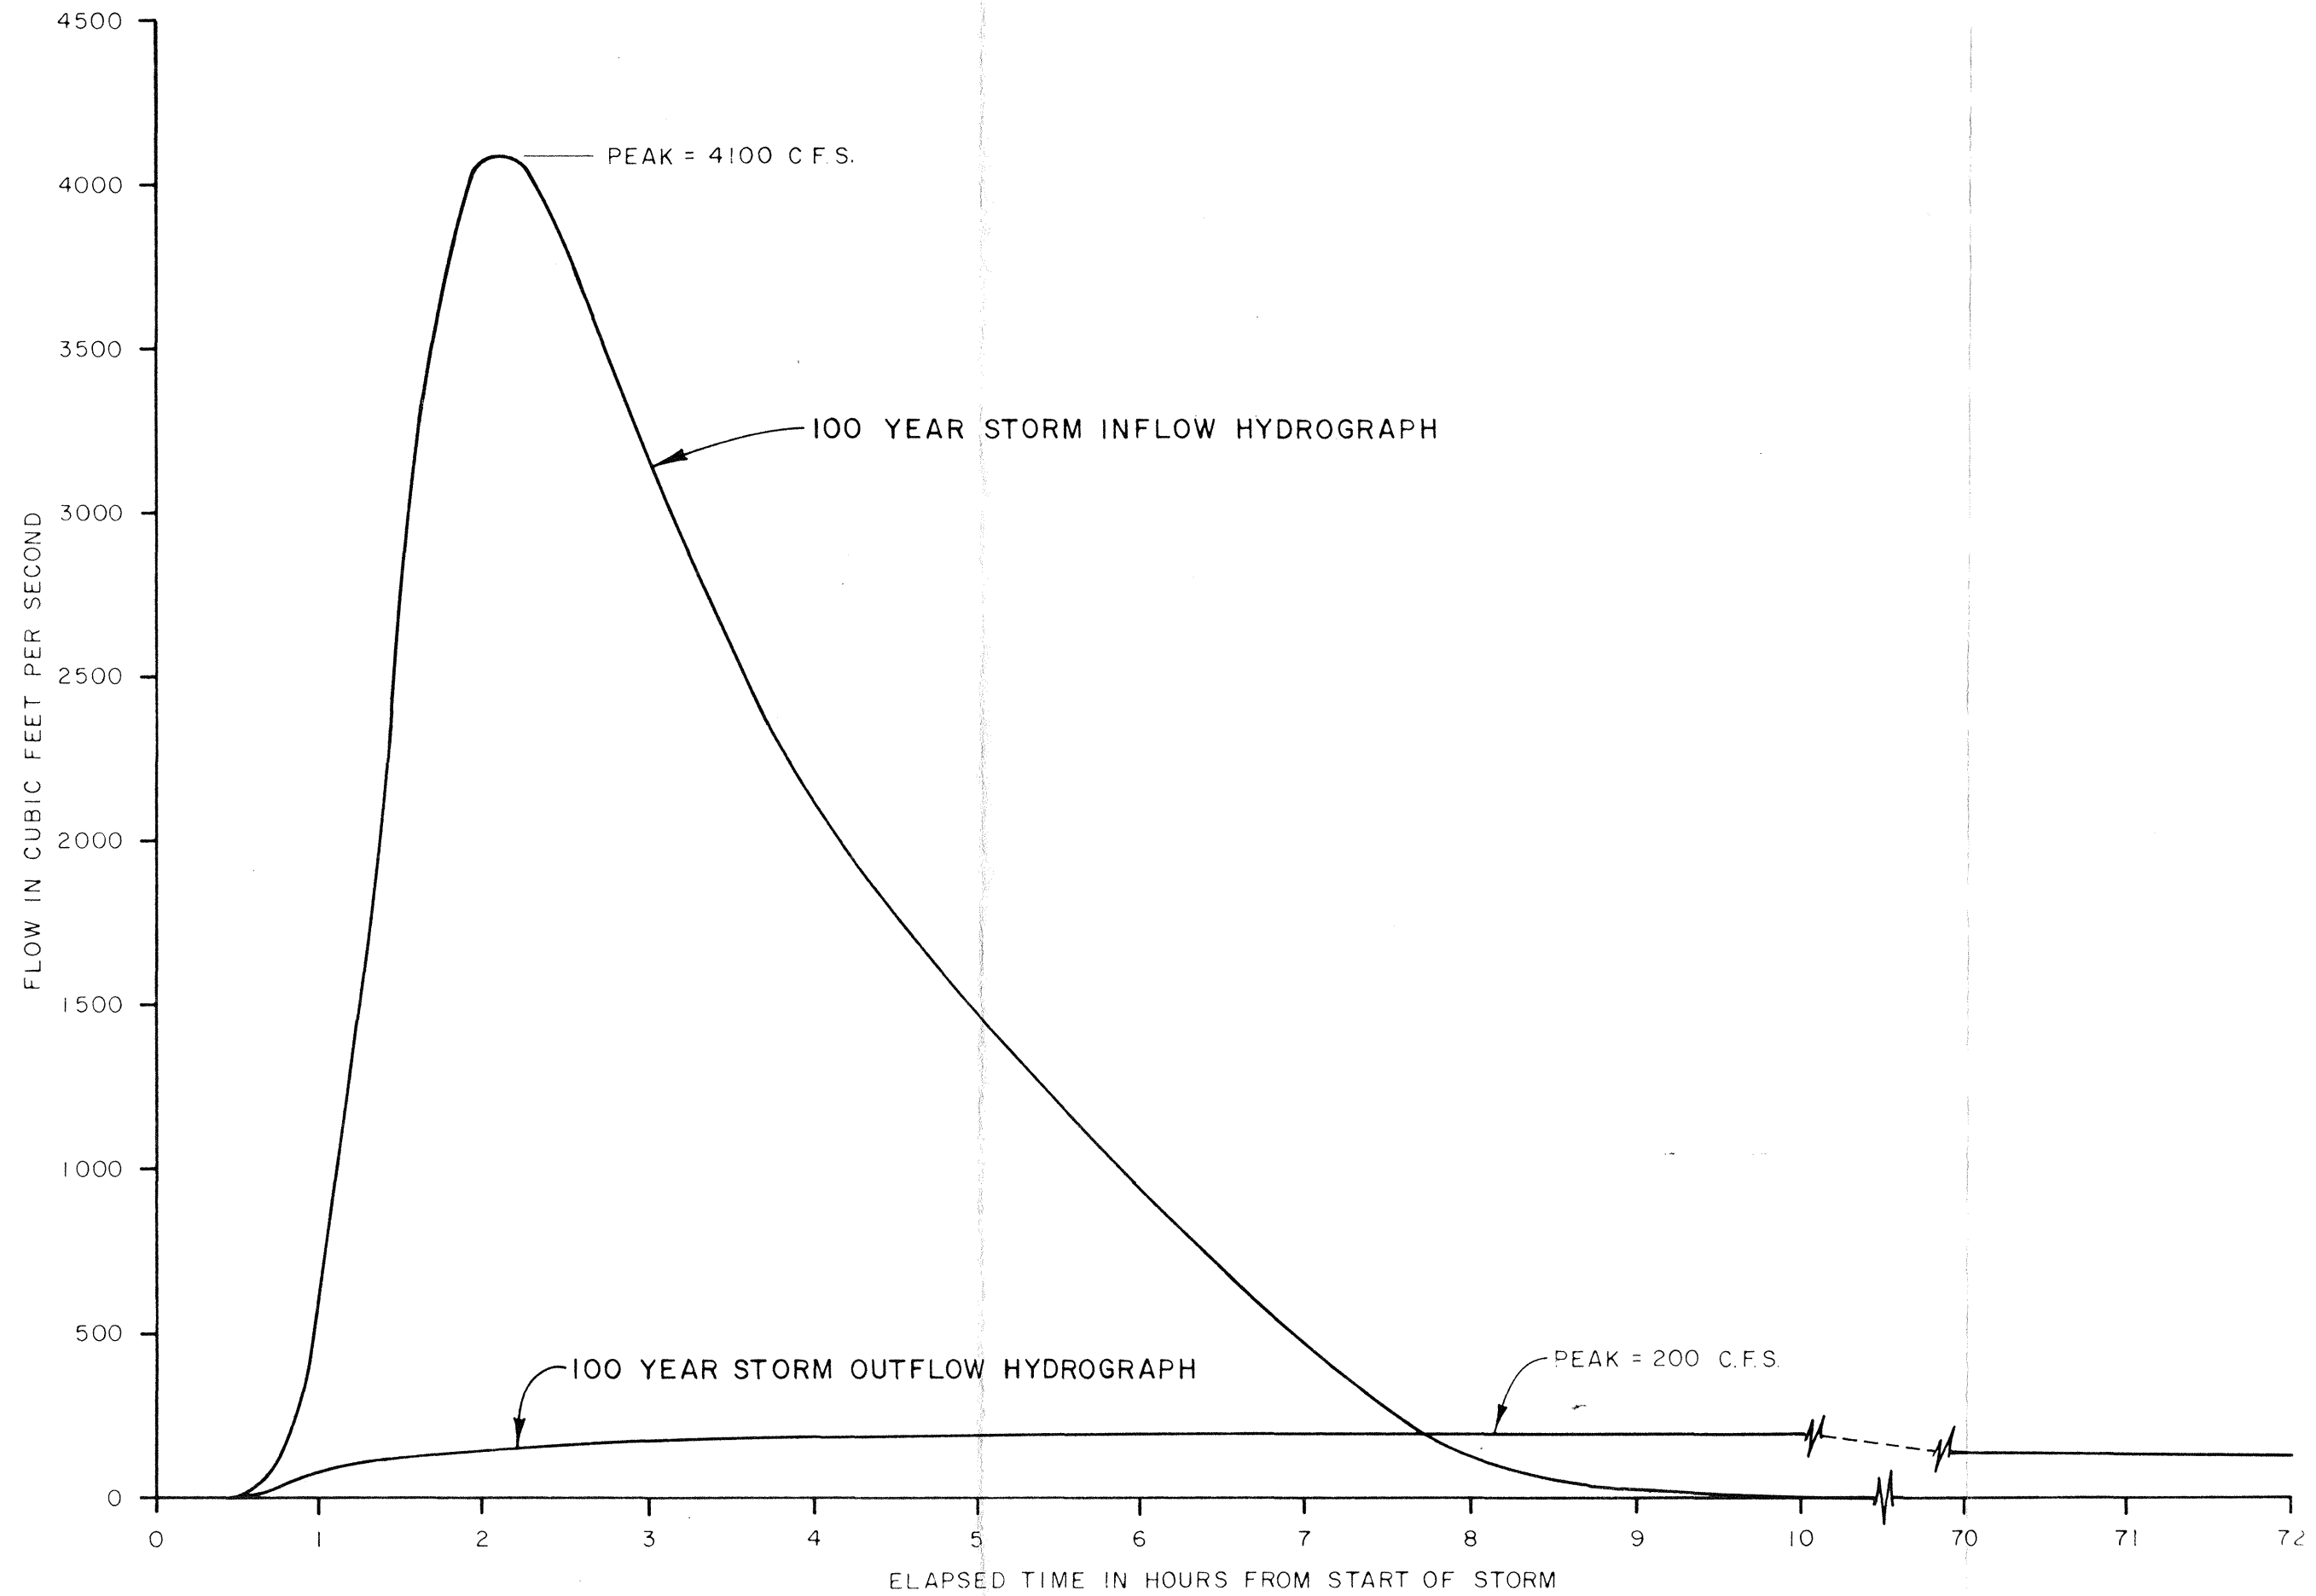
FIG. 12

100-year storm = 4.7 inches in 6 hours
PMP storm = 22 inches in 6 hours
Time of storm concentration = 1.5 hours
Runoff Factor = Curve No. of 80*
100-year storm peak = 4100 cubic feet per second
(Figure 12)

Results of our analyses indicate the existing dam should contain the 100-year average frequency flood occurrence assuming operation of the ungated outlet. Although water level would be at emergency spillway crest elevation, as shown on Figure 15, the emergency spillways would not operate. We would expect less frequent storm occurrences to result in operation of the emergency spillways.
